**PRELIMINARY ASSESSMENT/  
VISUAL SITE INSPECTION**

**AIRTEX PRODUCTS DIVISION  
UNITED INDUSTRIAL SYNDICATE  
FAIRFIELD, ILLINOIS  
ILD 001 662 816**

**FINAL REPORT**

**U.S. ENVIRONMENTAL PROTECTION AGENCY  
Office of Waste Programs Enforcement  
Washington, DC 20460**

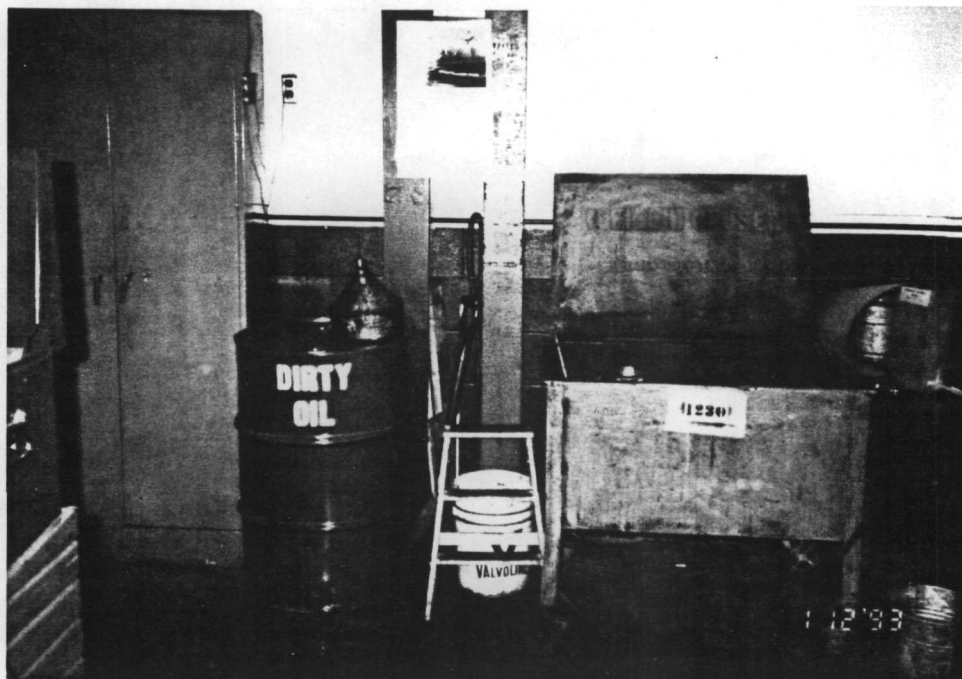
Location: SWMU 1  
 Date: 01/12/93

Photograph No. 1  
 Orientation: West  
 Description: Dirty Oil SAA and mineral spirits parts washer located in the Plant 1 Maintenance Department.

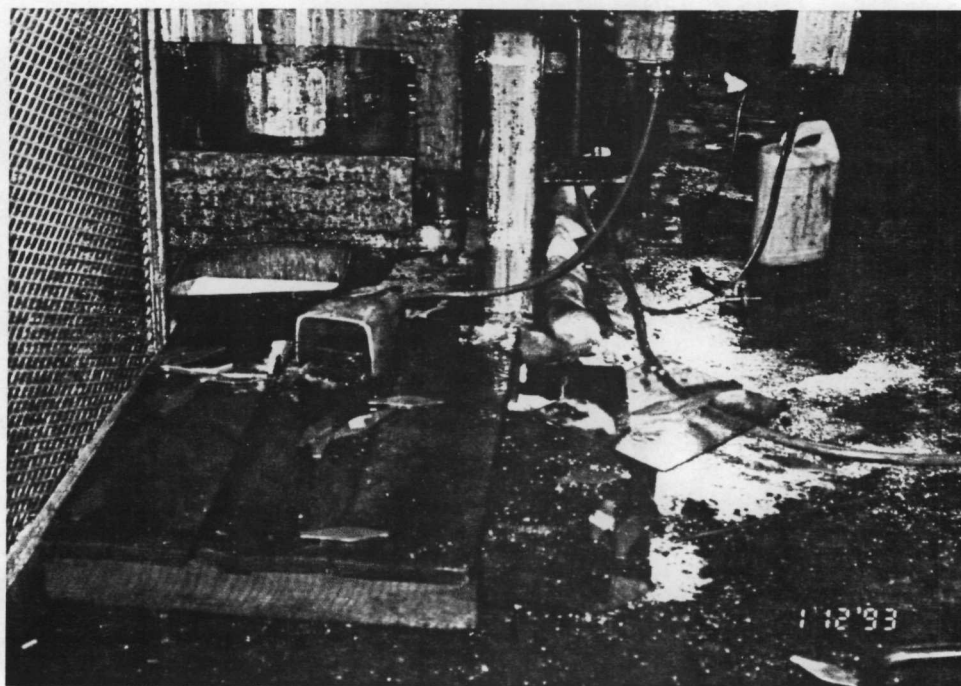
Location: SWMU 1  
 Date: 01/12/93

**Observations:** Each of the SAA drums were stored with closed lids during the VSI. No evidence of a release was observed near any of the drums; however, waste oil was spilled on the floor in several areas throughout the plant near the collection pan SAAs used to catch oil leaking from various manufacturing equipment (see Photograph Nos. 1 through 5).

Photograph No. 2  
 Orientation: South  
 Description: Oil spilled on the floor in Department No. 44, Plant 1, near one of the Dirty Oil SAA collection pans.

**Recommendations:**              PRC recommends that the facility implement better waste oil containment systems on manufacturing equipment to prevent spills of waste oil to the facility floors.

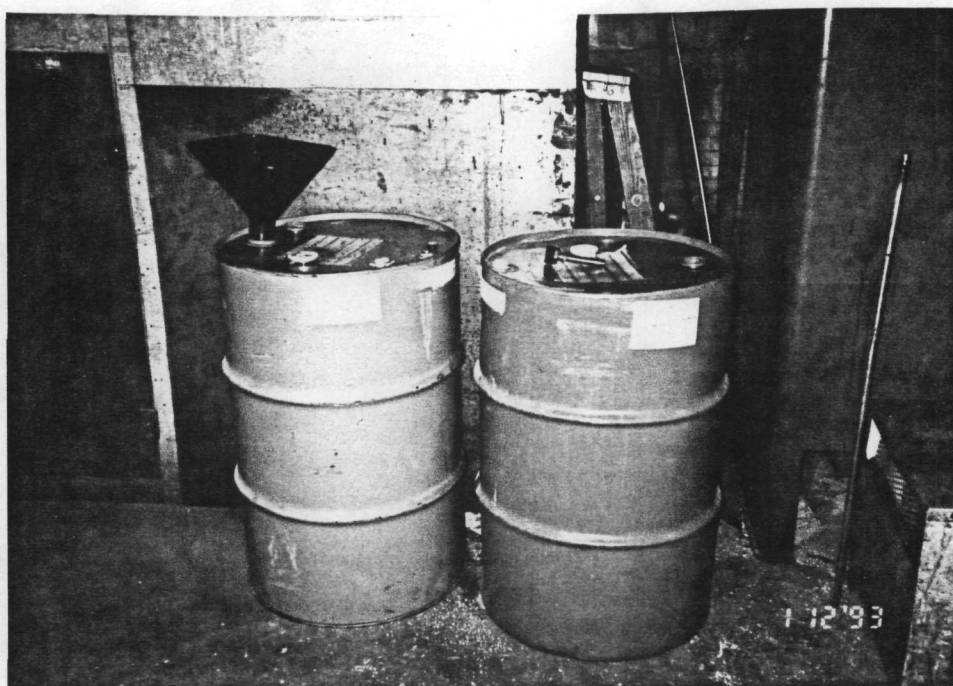
Location: SWMU 1  
 Date: 01/12/93

Photograph No. 3  
 Orientation: West  
 Description: Dirty Oil SAA located in Plant 1 Department No. 46.

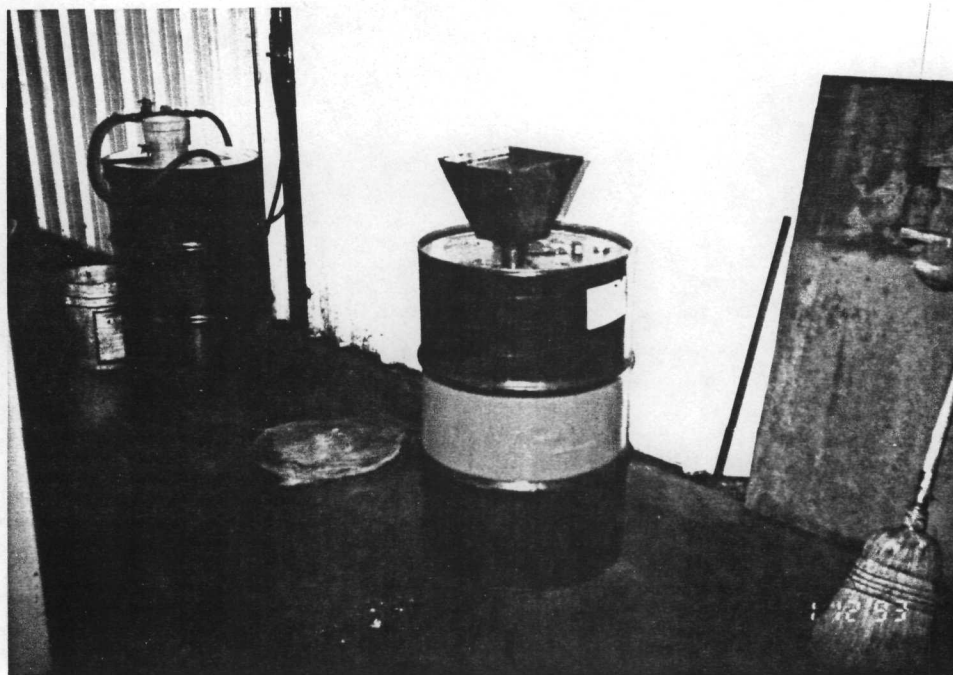
Location: SWMU 1  
 Date: 01/12/93

Photograph No. 4  
 Orientation: Southeast  
 Description: Dirty Oil SAA located in Department No. 42.

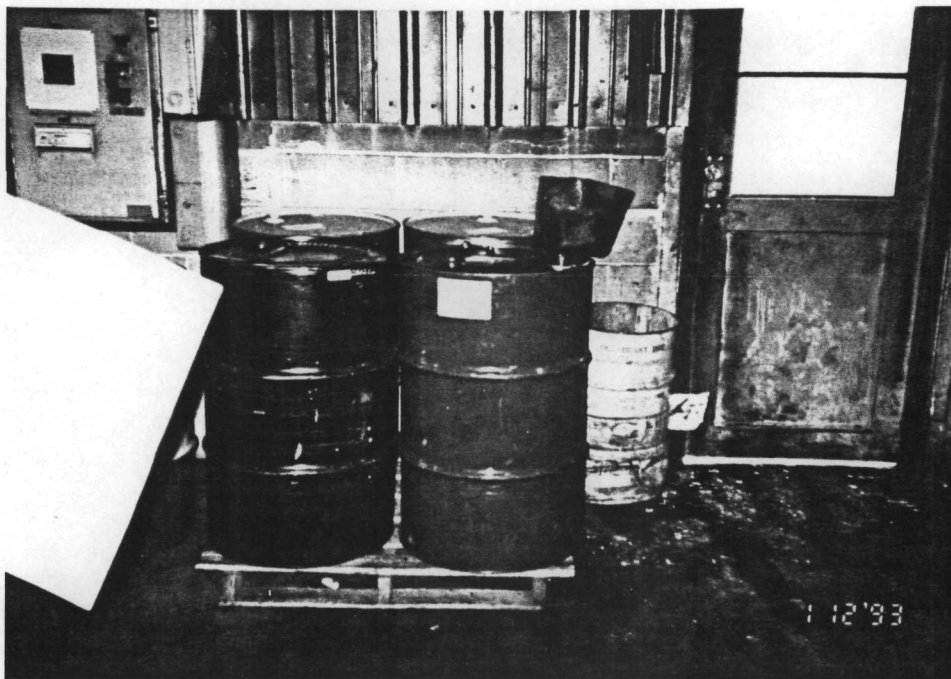
Location: SWMU 1  
 Date: 01/12/93

Photograph No. 5  
 Orientation: West  
 Description: Dirty Oil SAA located at Plant 2.

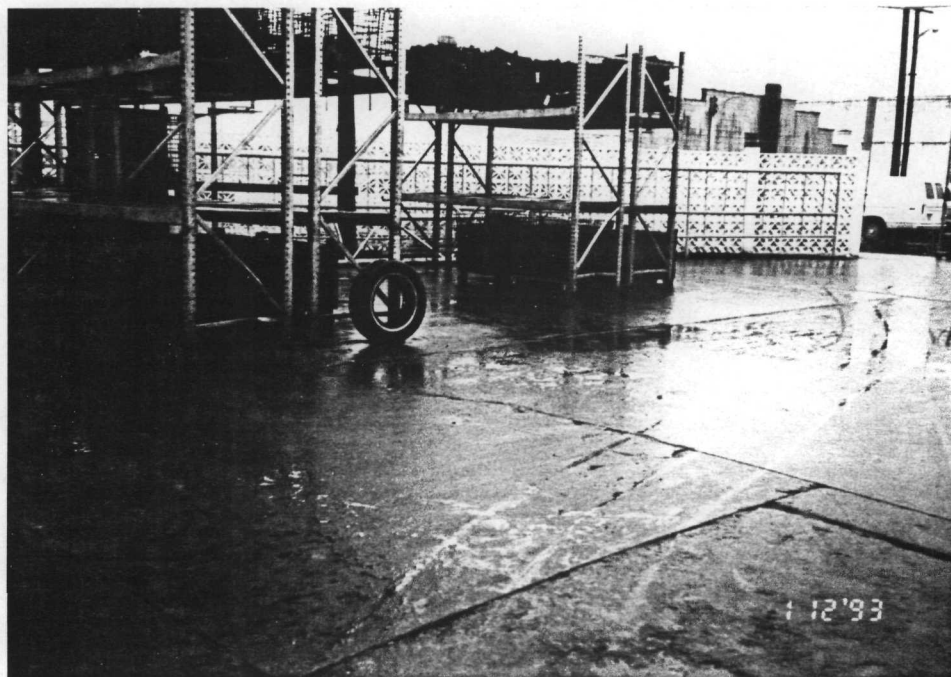
Location: SWMU 2  
 Date: 01/12/93

**Observations:** This area is currently used to store various product chemicals. No waste material was observed in this area, and no evidence of a release was observed (see Photograph No. 6).

Photograph No. 6  
 Orientation: Southwest  
 Description: Former Outdoor Waste Oil Storage Area located south of Department No. 44.

**Recommendations:**              No further action is recommended at this time.

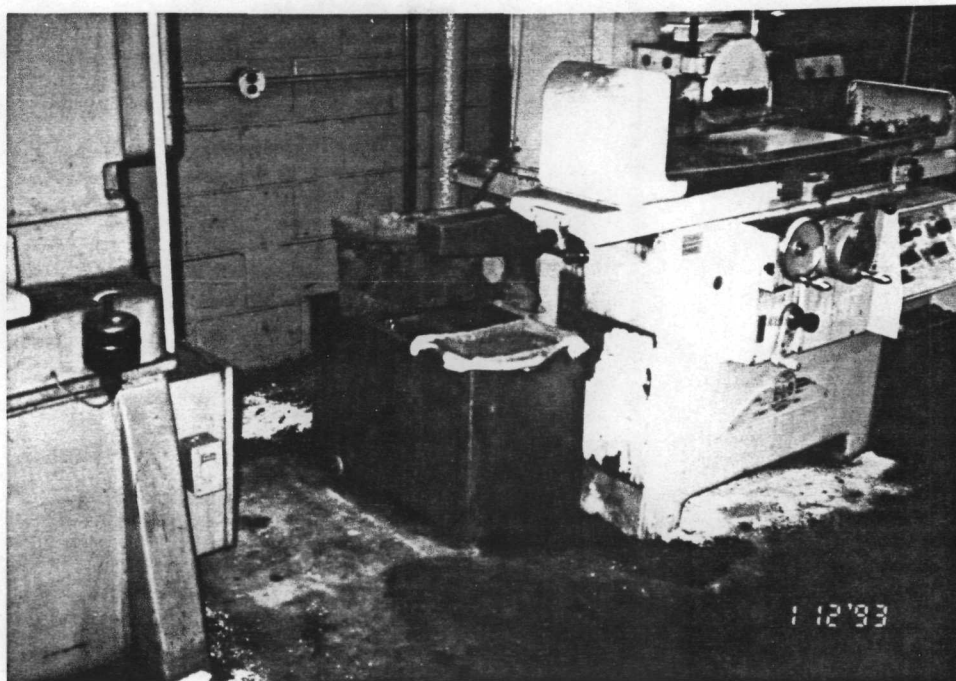
Location: SWMU 3  
 Date: 01/12/93

**Observations:** Each of these units throughout the facility were observed during the VSI. Some evidence of spills were noted on the concrete floors surrounding some of the units (see Photograph No. 7).

Photograph No. 7  
 Orientation: Southeast  
 Description: Metal Grit SAA box located in the Tool Room in Plant 1.

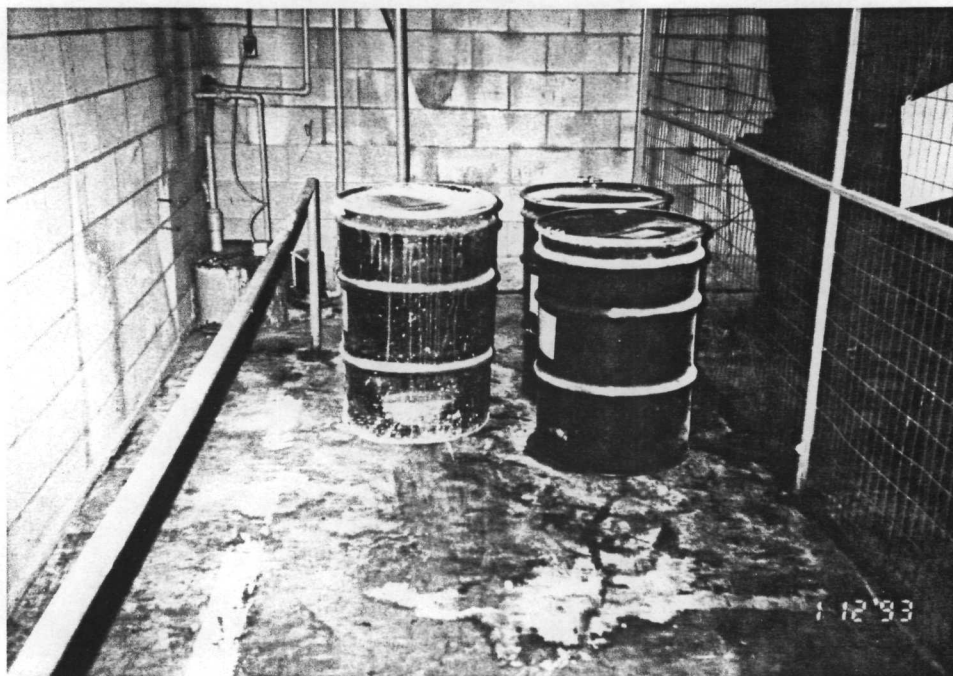
Location: SWMU 4  
 Date: 01/12/93

<b>Release Controls:</b>	This unit is located indoors on a concrete floor. Some cracks in the floor were observed during the VSI. There are no floor drains at the facility.
<b>History of Documented Releases:</b>	There have been no documented releases from this unit.
<b>Observations:</b>	Three 55-gallon drums of plating sludge were observed in this area during the VSI. The area is surrounded by a locked chain-link fence. Some corrosion of the concrete floor was observed near the drums during the VSI (see Photograph No. 8). Facility representatives stated that although the area now surrounded by the chain-link fence is only 12- by 20-feet (the area specified by the Part A permit application), up to 60 drums at a time have been stored in the general area of this SWMU in the past.

Photograph No. 8  
 Orientation: North  
 Description: Former Plant 1 RCRA Container Storage Area located in Department No. 44.

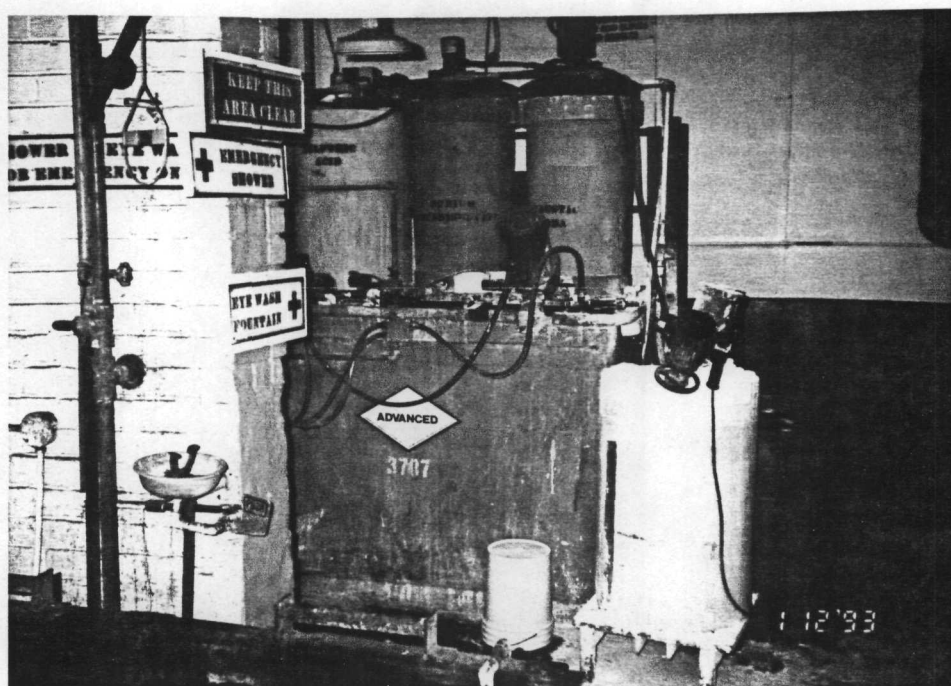
Photograph No. 9

Release Controls:	This unit is located in the Plating Department, Plant 1, on a concrete floor. Open concrete floor drains direct water from the plating area to the concrete floor sump to begin the pretreatment process. The sump has no secondary containment. No cracks were observed in the floor, drains, or sump.
History of Documented Releases:	There have been no documented releases from this unit; however, a review of the available file information indicates that before 1972, untreated plating wastewater was discharged to a storm sewer, which discharged into Johnson Creek.
Observations:	This unit was in operation during the VSI. No evidence of a release was observed (see Photograph Nos. 9 and 10).

Description: Treatment tanks located at the wastewater treatment system at Plant 1 for the addition of sulfuric acid, sodium metabisulfite, and sodium hydroxide.

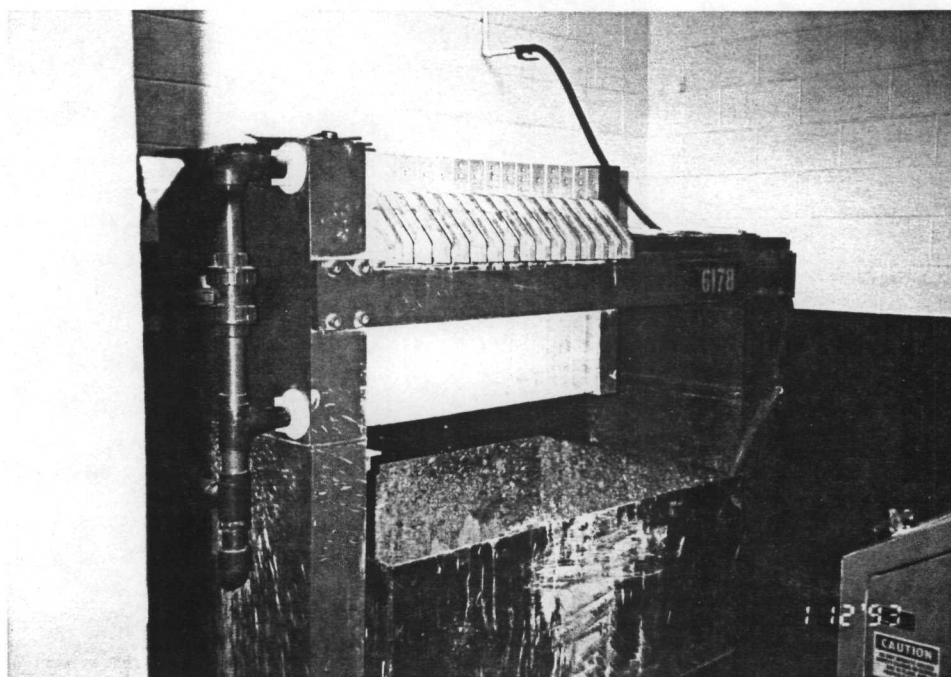
Photograph No. 10

Description: Filter press section of wastewater treatment system at Plant 1.

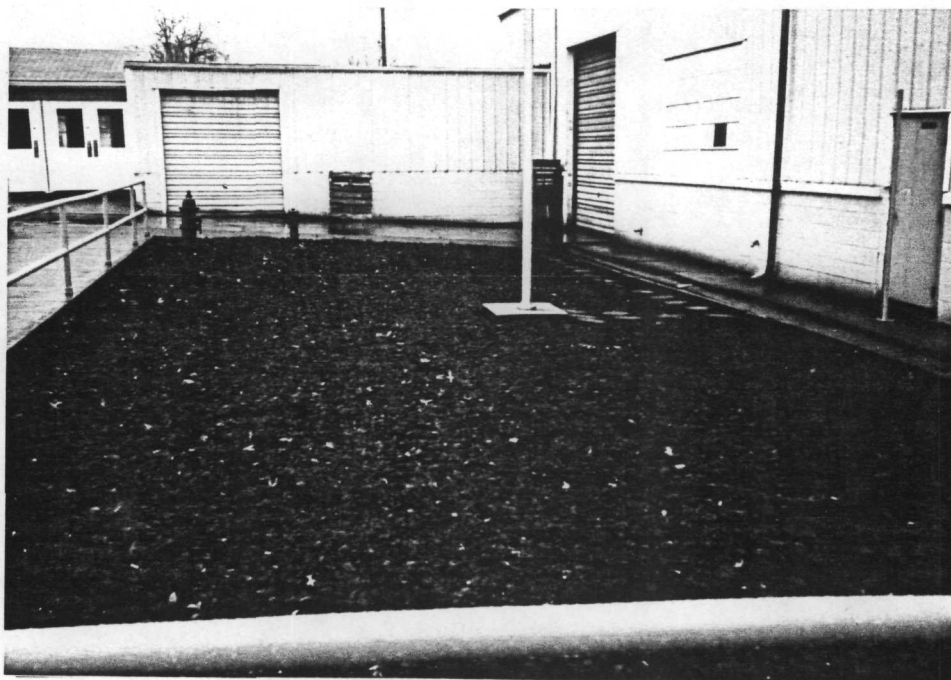
Location: SWMU 7  
 Date: 01/12/93

Photograph No. 11  
 Orientation: North Northeast  
 Description: Former location of fuel oil UST at Plant 2 removed in 1984.

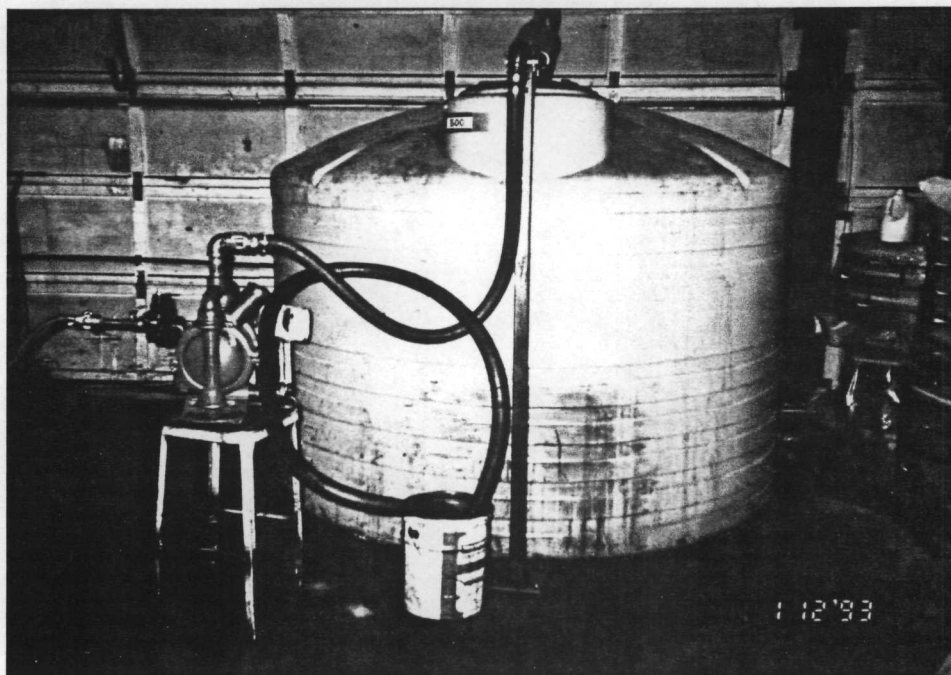
Location: SWMU 9  
 Date: 01/12/93

**Observations:** These tanks were all in use at the time of the VSI. The tanks appeared to be well maintained and no evidence of a release was noted (see Photograph Nos. 12 and 13).

Photograph No. 12  
 Orientation: East  
 Description: Waste Oil for Reclamation Storage Tank located in Department No. 76 at Plant 1.

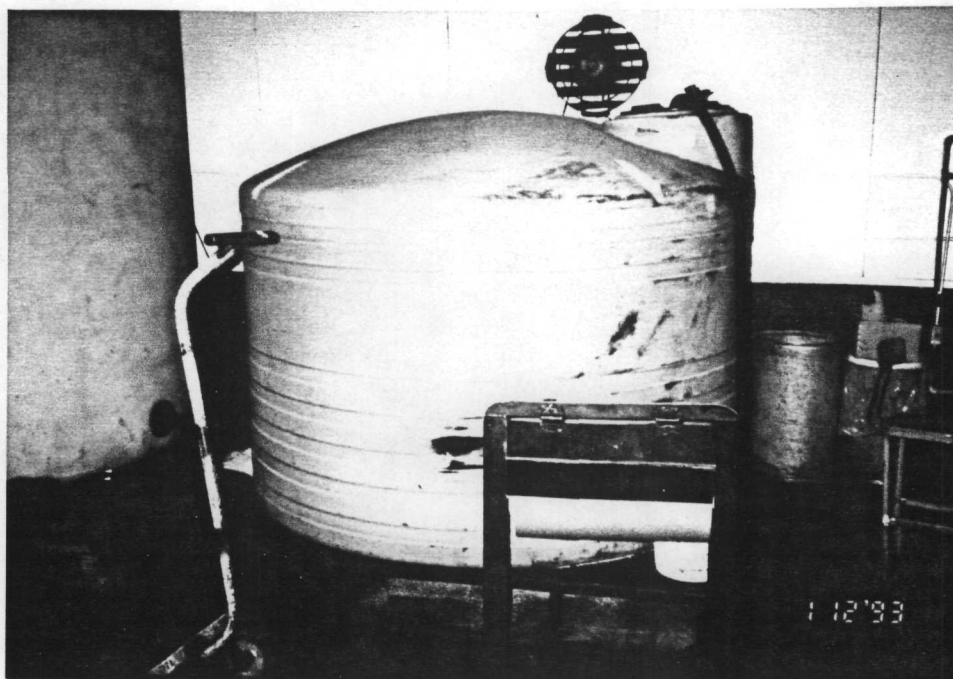
Photograph No. 13

Description: Waste Oil for Reclamation Tank located in Plant 2, Department No. 89.

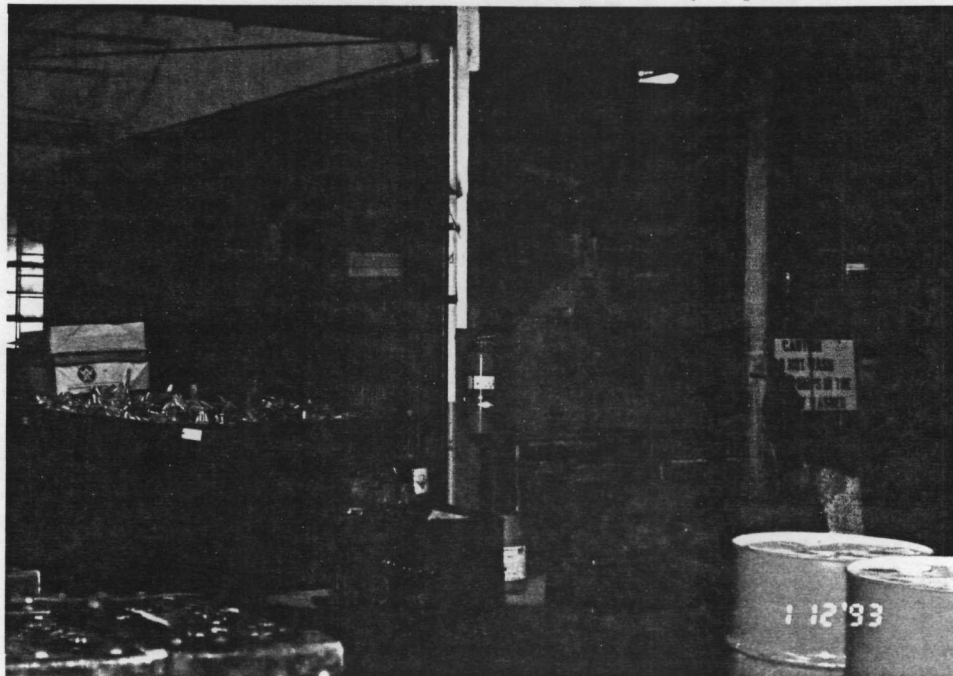
Photograph No. 14

Description: Ranshoff Washer and Udylyte washer, which use soap and water to wash various parts. The wastewater and oil mixture generated in the washers is taken to the Wastewater Evaporation System (SWMU 9) for treatment.

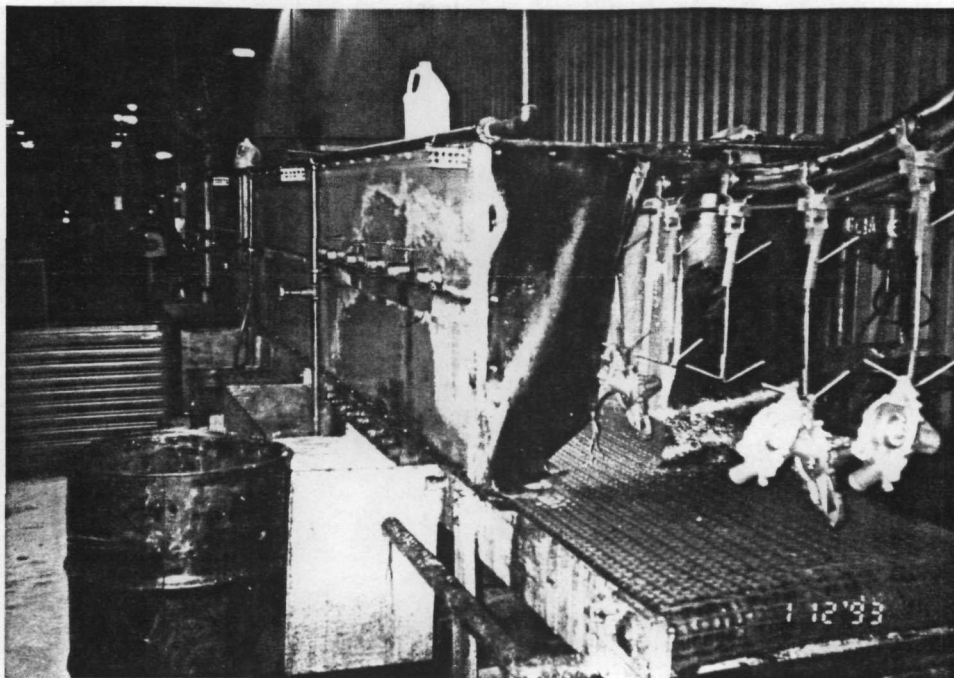
Photograph No. 15

Description: Parts washer in Plant 2, Department No. 54, which uses soap and water to remove oil from various parts. The wastewater and oil mixture generated in the washer is taken to the Wastewater Evaporation System (SWMU 9) for treatment.

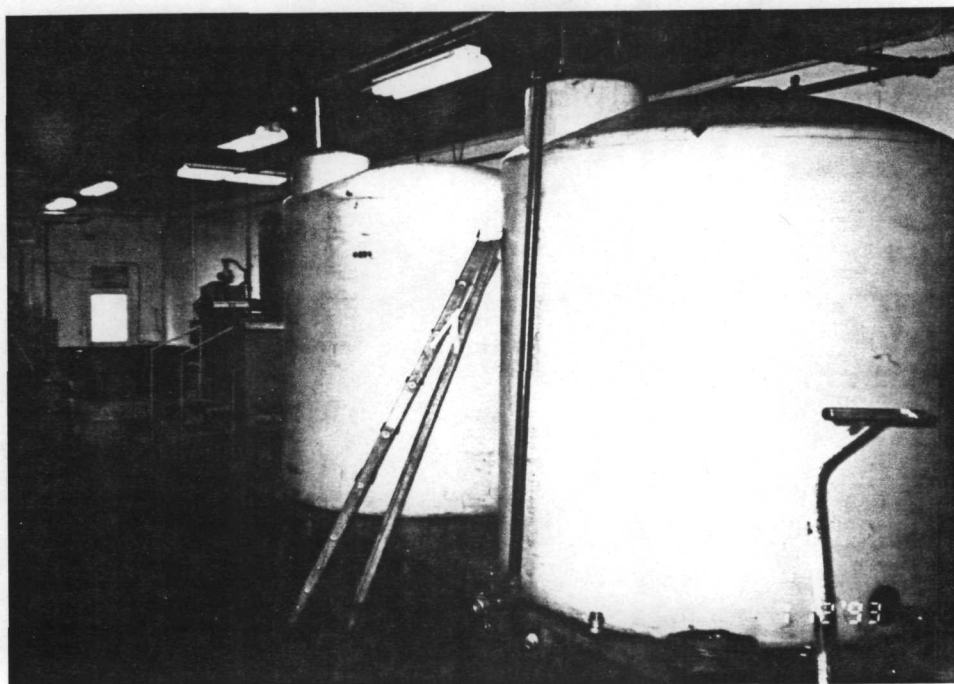
Photograph No. 16

**Observations:** This unit was in operation during the VSI. No evidence of a release at the evaporation unit was observed (see Photograph No. 16).

Description: Wastewater Evaporation System at Plant 2, Department No. 89.

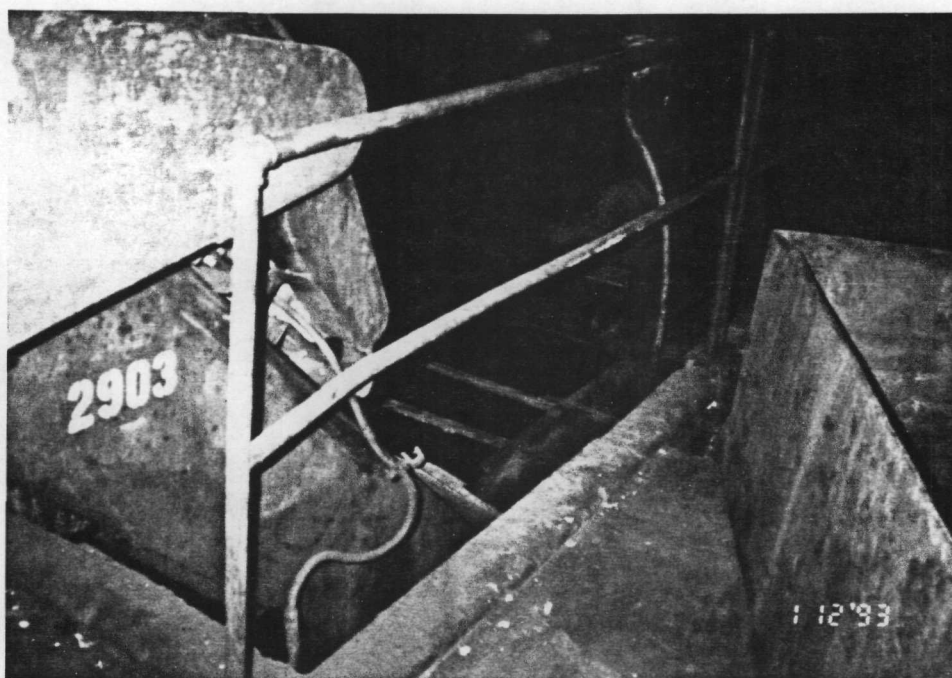
Photograph No. 17

**Observations:** This unit was in use during the VSI. No evidence of a release was observed, although the bottom of the concrete sump could not be inspected because there was coolant in the system (see Photograph No. 17).

Description: Hanchett Pit Wastewater Treatment System at Plant 2, which reclaims used surface grinding coolant wastewater by removing metal grit.

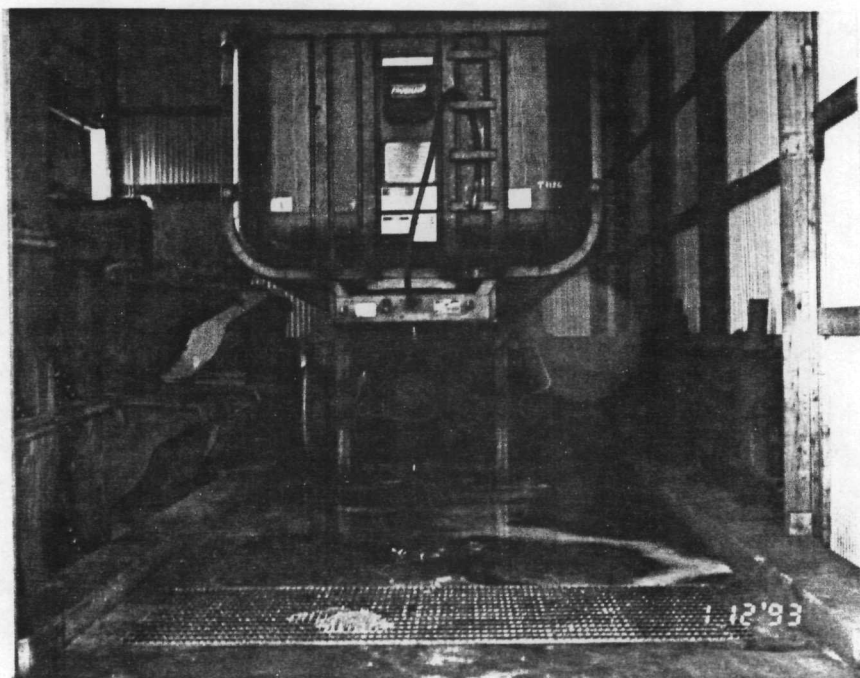
Photograph No. 18

<b>Release Controls:</b>	This building has a concrete floor. The truck trailer is parked on a concrete, bermed area which drains to a concrete sump. No cracks in the floor were observed during the VSI.
<b>History of Documented Releases:</b>	There have been no documented releases from this unit.
<b>Observations:</b>	This unit was being used to collect cast iron borings in the truck trailer during the VSI. No evidence of the former RCRA container storage area was visible. No waste oil was observed draining from the trailer during the VSI; however, waste oil and water mixture were observed in the concrete sump (see Photograph No. 18).

Description: Cast iron boring truck trailer and waste oil collection pit at the Former Plant 2 RCRA Container Storage Area.

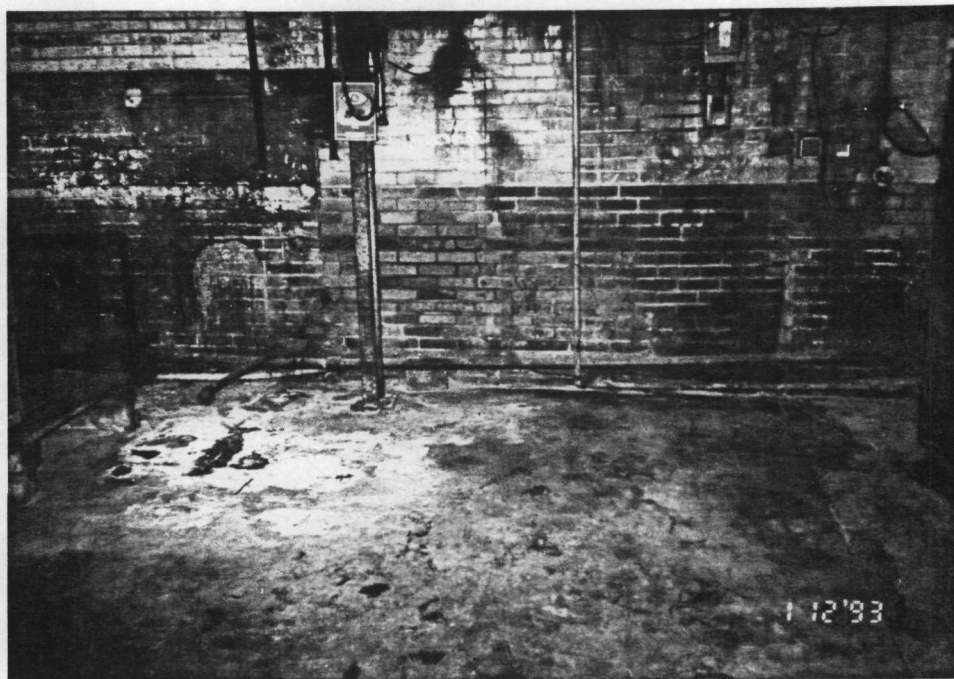
Photograph No. 19

No evidence of the former still remains in this area. No evidence of a release was observed (see Photograph No. 19).

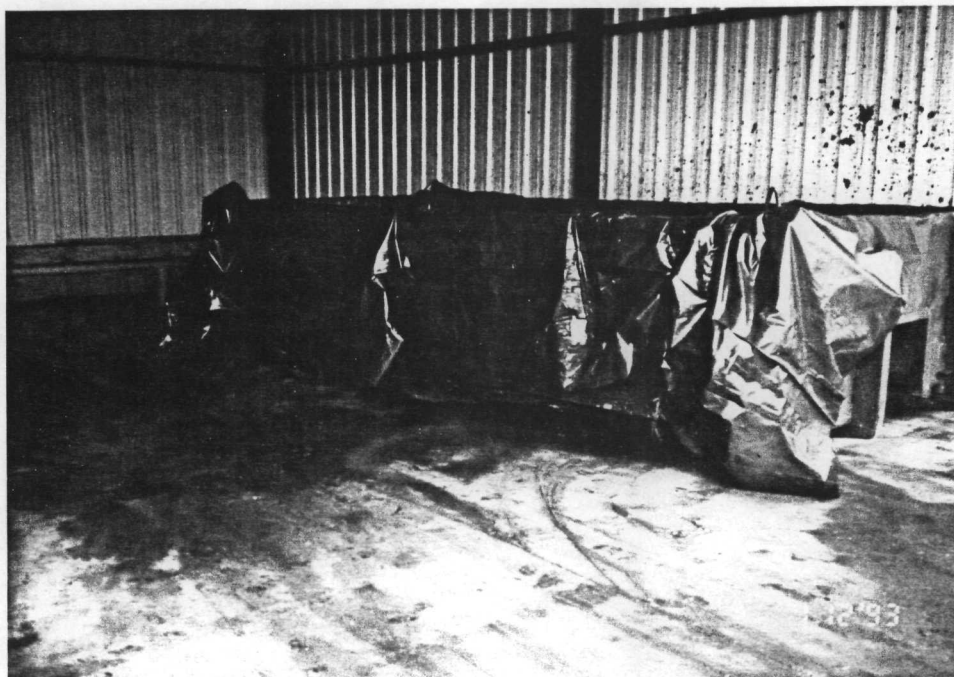
Photograph No. 20

The dumpster was in use and about one-half full during the VSI. No wastes other than the special wastes appeared to be in the dumpster. Metal grit sludge could be seen on the floor of the building during the VSI (see Photograph No. 20).

Location: SWMU 12

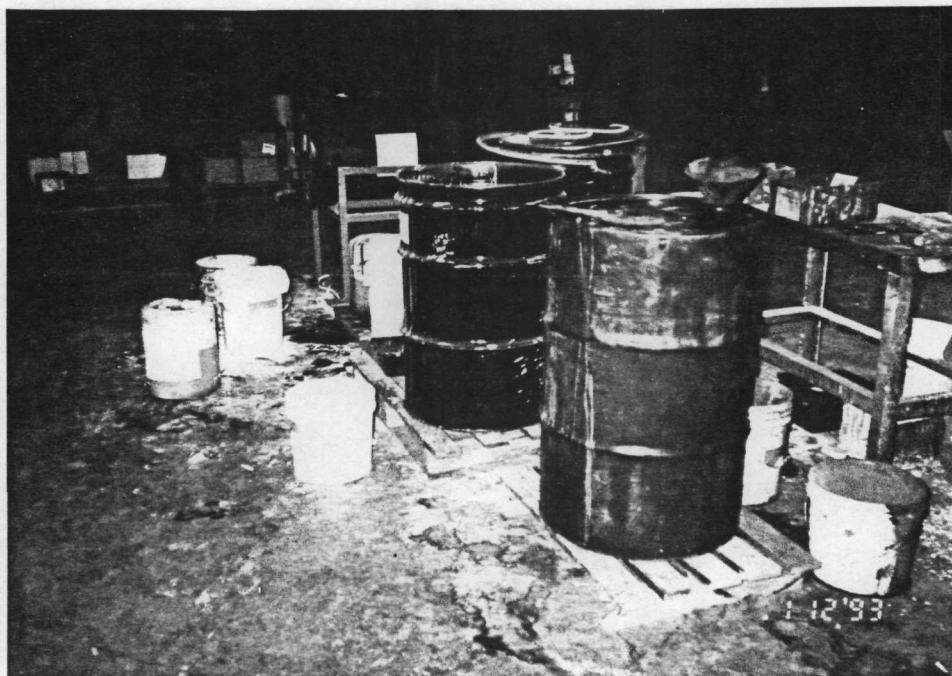
Location: SWMU 14  
 Date: 01/12/93

Wastes Managed:	Waste resin, waste lapping compound, waste lapping compound mixed with water, and waste oil are generated at Plant 3 from the manufacture and assembly of various electronic parts. Waste resin and waste lapping compound are disposed of off site by Sanitation in the Effingham Landfill under Special Waste Permit Nos. 891236 (waste resin) and 890478 (waste lapping compound). Waste lapping compound mixed with water is taken to (SWMU 9) for treatment. Waste oil is taken to SWMU 8 for storage.
Release Controls:	The drums are stored inside the building on a concrete floor. No cracks were observed in the concrete. This building does not have any floor drains.
History of Documented Releases:	There have been no documented releases from this unit.
Observations:	All of the drums of waste material were stored closed during the VSI. Some waste lapping compound was spilled on the floor surrounding the waste lapping compound drums. No evidence of a release was observed in the other storage areas (see Photograph Nos. 21 through 23).

Photograph No. 21  
 Orientation: Southwest  
 Description: Waste lapping compound collection drums at Plant 3.

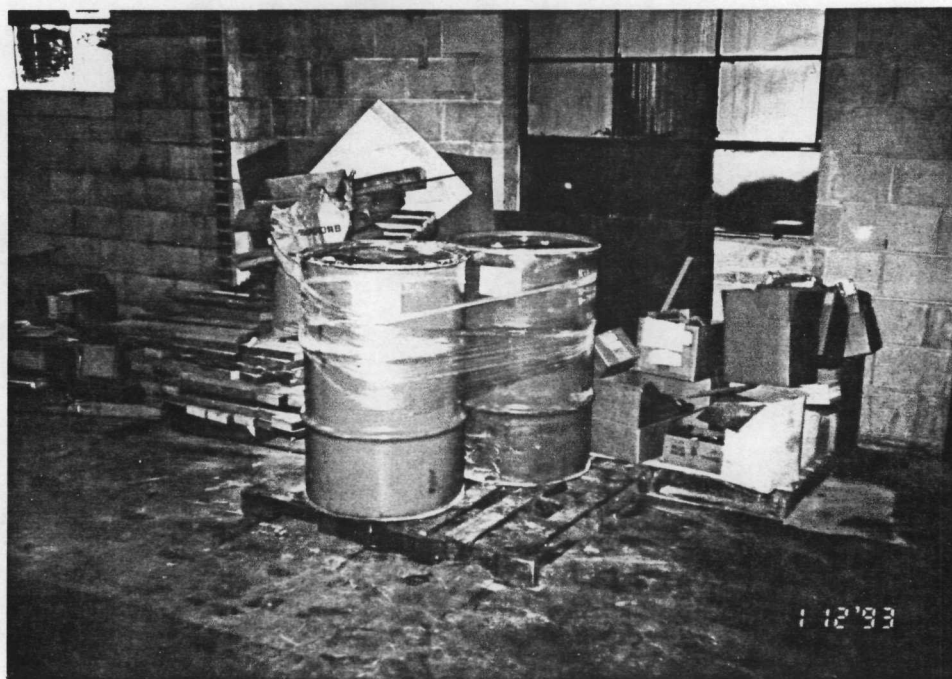
Location: SWMU 14  
 Date: 01/12/93

Photograph No. 22  
 Orientation: Northeast  
 Description: Waste resin collection drums at Plant 3.

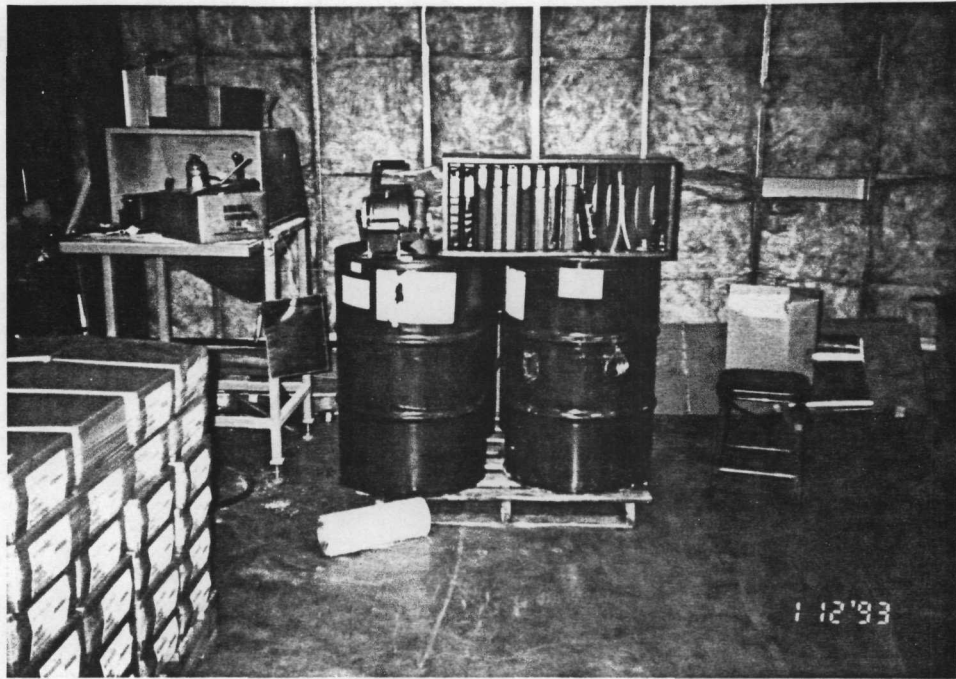
Location: SWMU 14  
Date: 01/12/93

Photograph No. 23  
Orientation: South  
Description: Waste lapping compound storage area at Plant 3.
